AERIAL PHOTOGRAPHIC ANALYSIS OF THE LARSON AFB STUDY AREA Moses Lake, Washington

EPA Region 10

TS-PIC-89818/90818-1
November 1989

M. A. Finkbeiner
Environmental Programs
Lockheed Engineering and Sciences Company
Las Vegas, Nevada 89193-3478

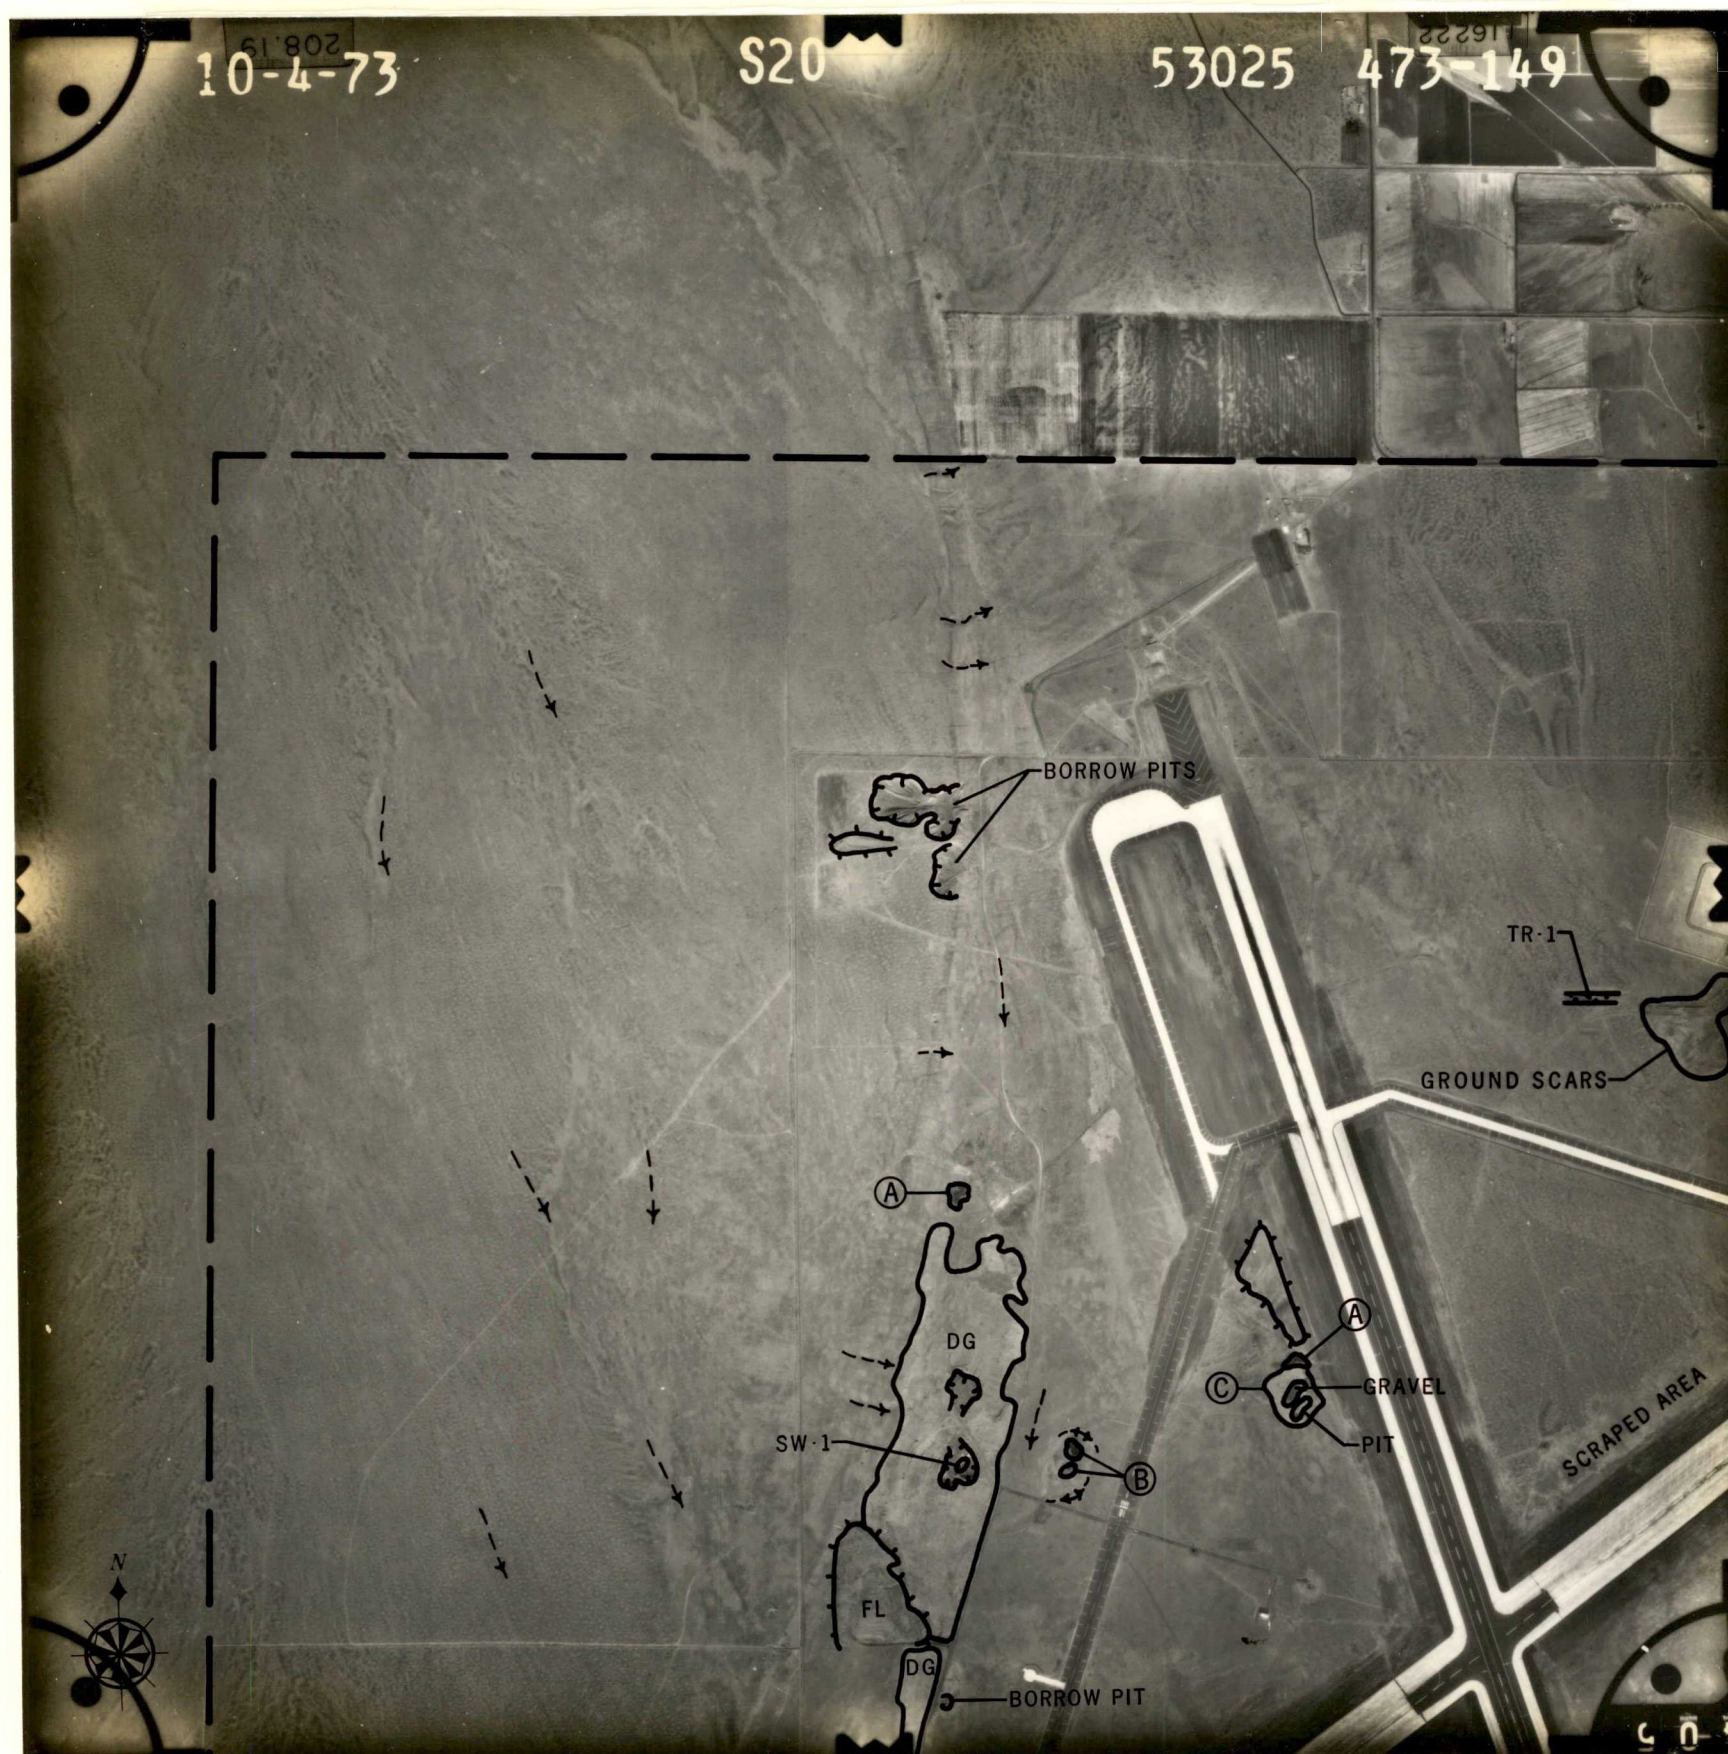
Figure 4 shows the northwest corner of the study area. Several features are noted which might indicate waste handling or disposal. Potential environmental hazardous are:

Annotation B: These are two probable burn areas. Rows of crates or other objects are visible in the center of both areas. Containment ditches surround both of them.

Annotation C: This area of light-toned ground appears to be the result of dumping of ash or concrete on the ground. A pit is noted in the southern part of this area. A darker tone is shown by what appears to be gravel spread over the ground surface.

TR-1: No burial activity is visible in this large trench.

Additional features of interest on this frame are an extensive area of disturbed ground. No waste disposal can be confirmed in this area or at the mound of fill material.

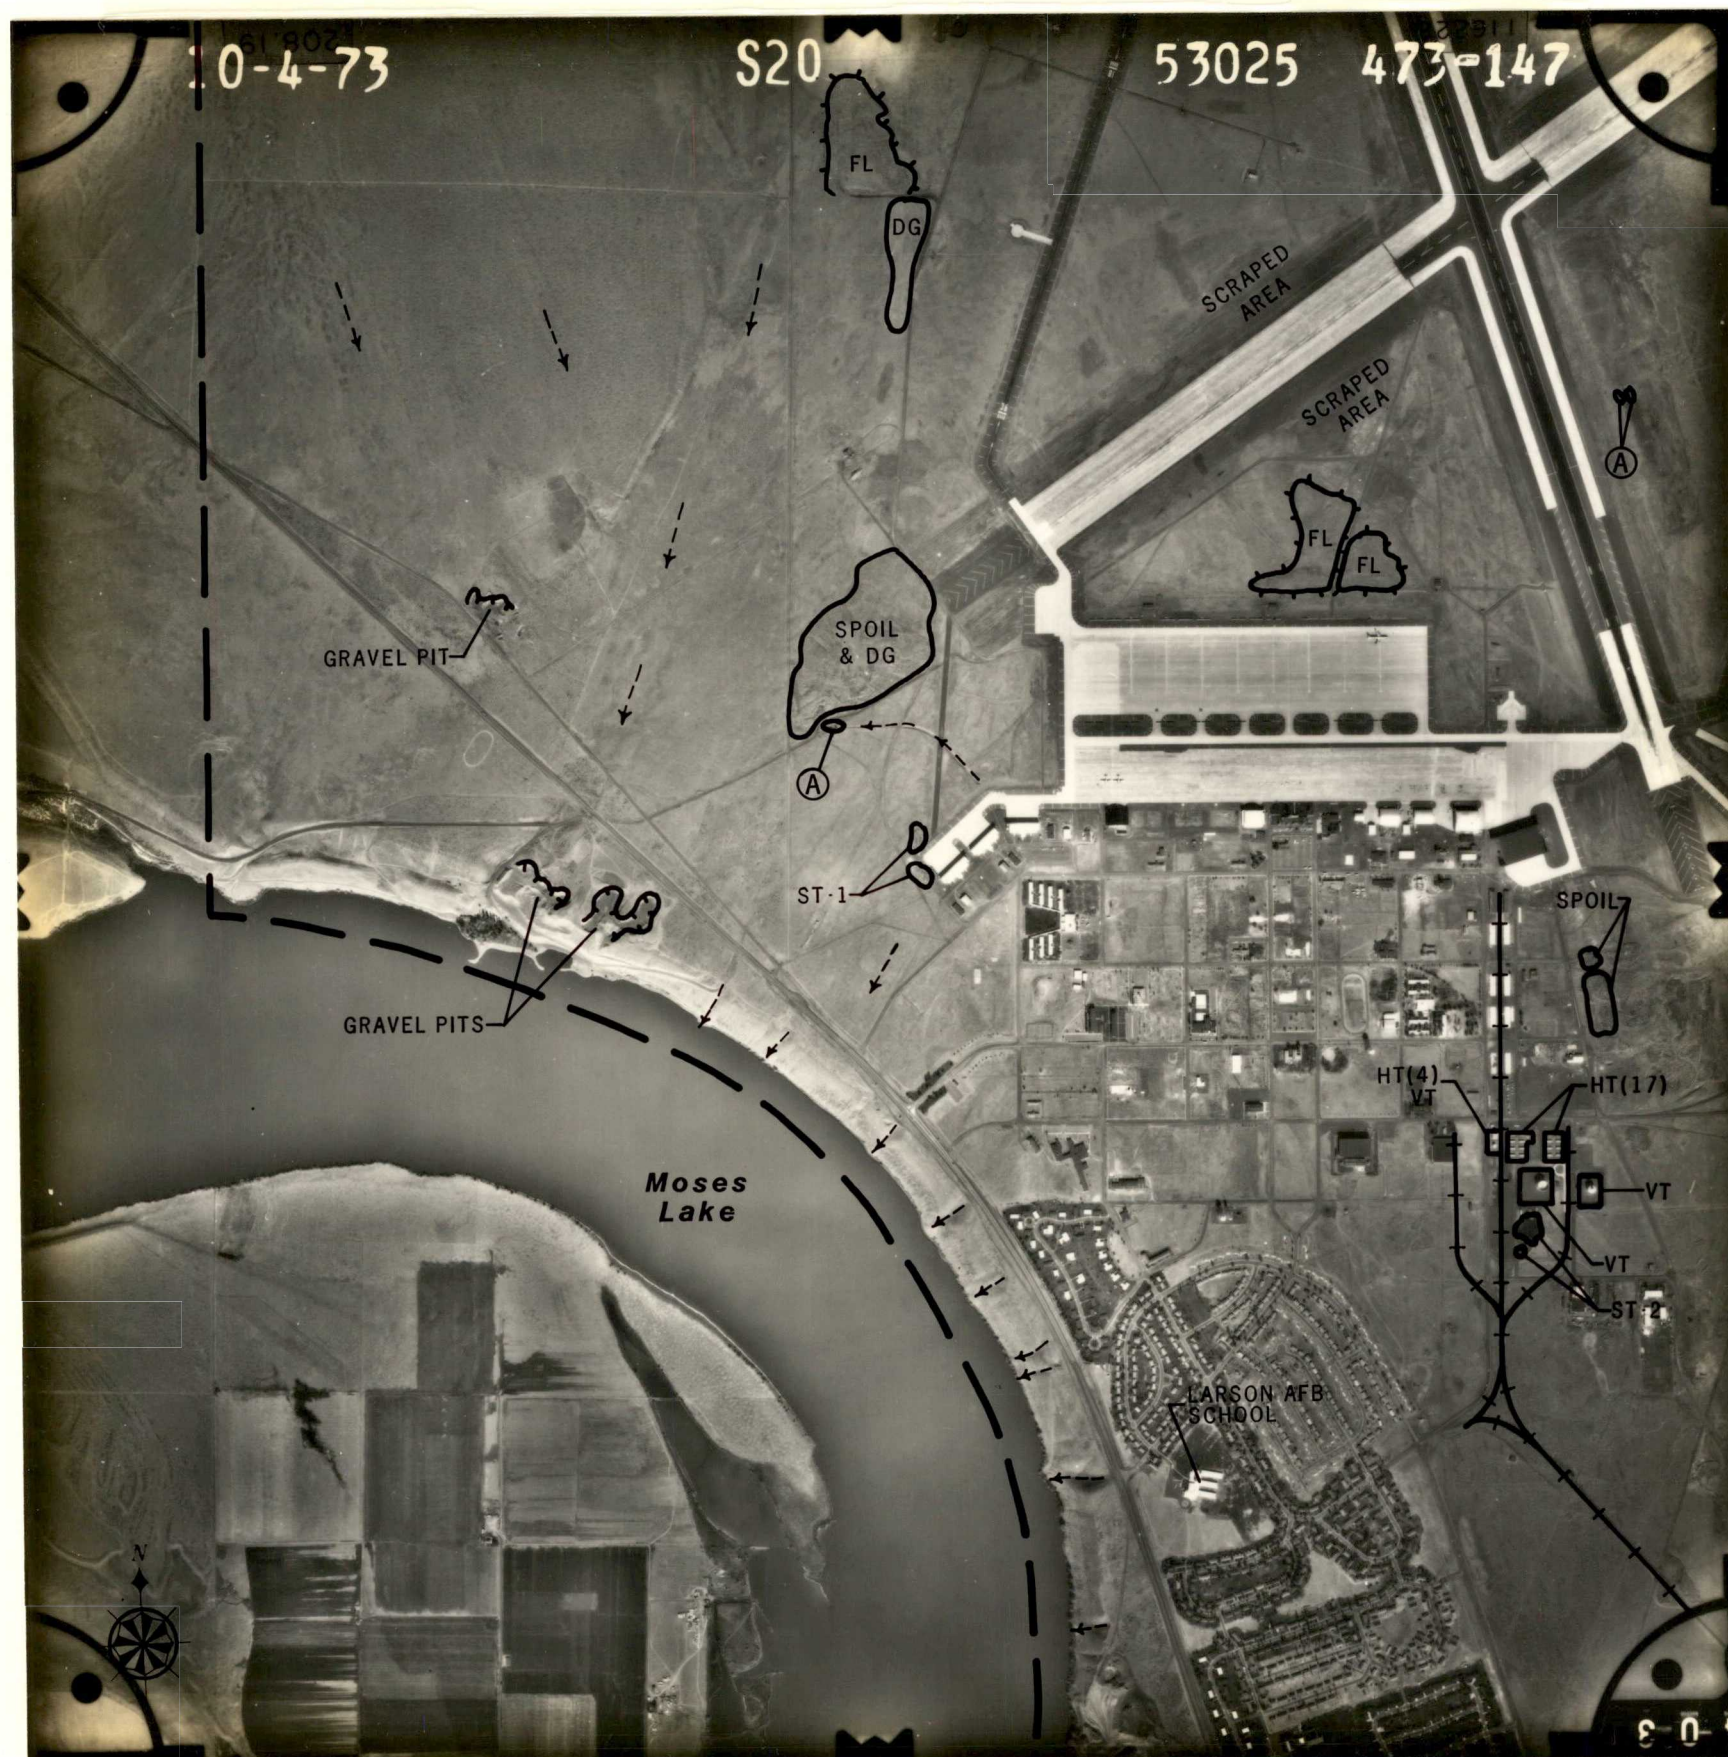
Figure 5 shows the southwest corner of the study area. Several gravel pits are present in this part of the study area. The main Air Force Base facilities and some residential areas are also noted. Potential environmental hazards are:

ST-1: Numerous dark liquid stains are visible in these two areas. They are probably the result of disposal of relatively small amounts of waste liquid on the ground.

ST-2: Two areas of heavy dark staining are noted near the bulk liquid storage area. The extent and location of this staining suggest that it may be associated with ground oiling as part of dust suppression measures.

Other significant features are an extensive area of spoil and disturbed ground at the end of a main runway. No waste disposal is noted at this area or at the other fill areas on this frame. Twenty-one horizontal and three vertical tanks are present along the railroad tracks as well as several pressure tanks.

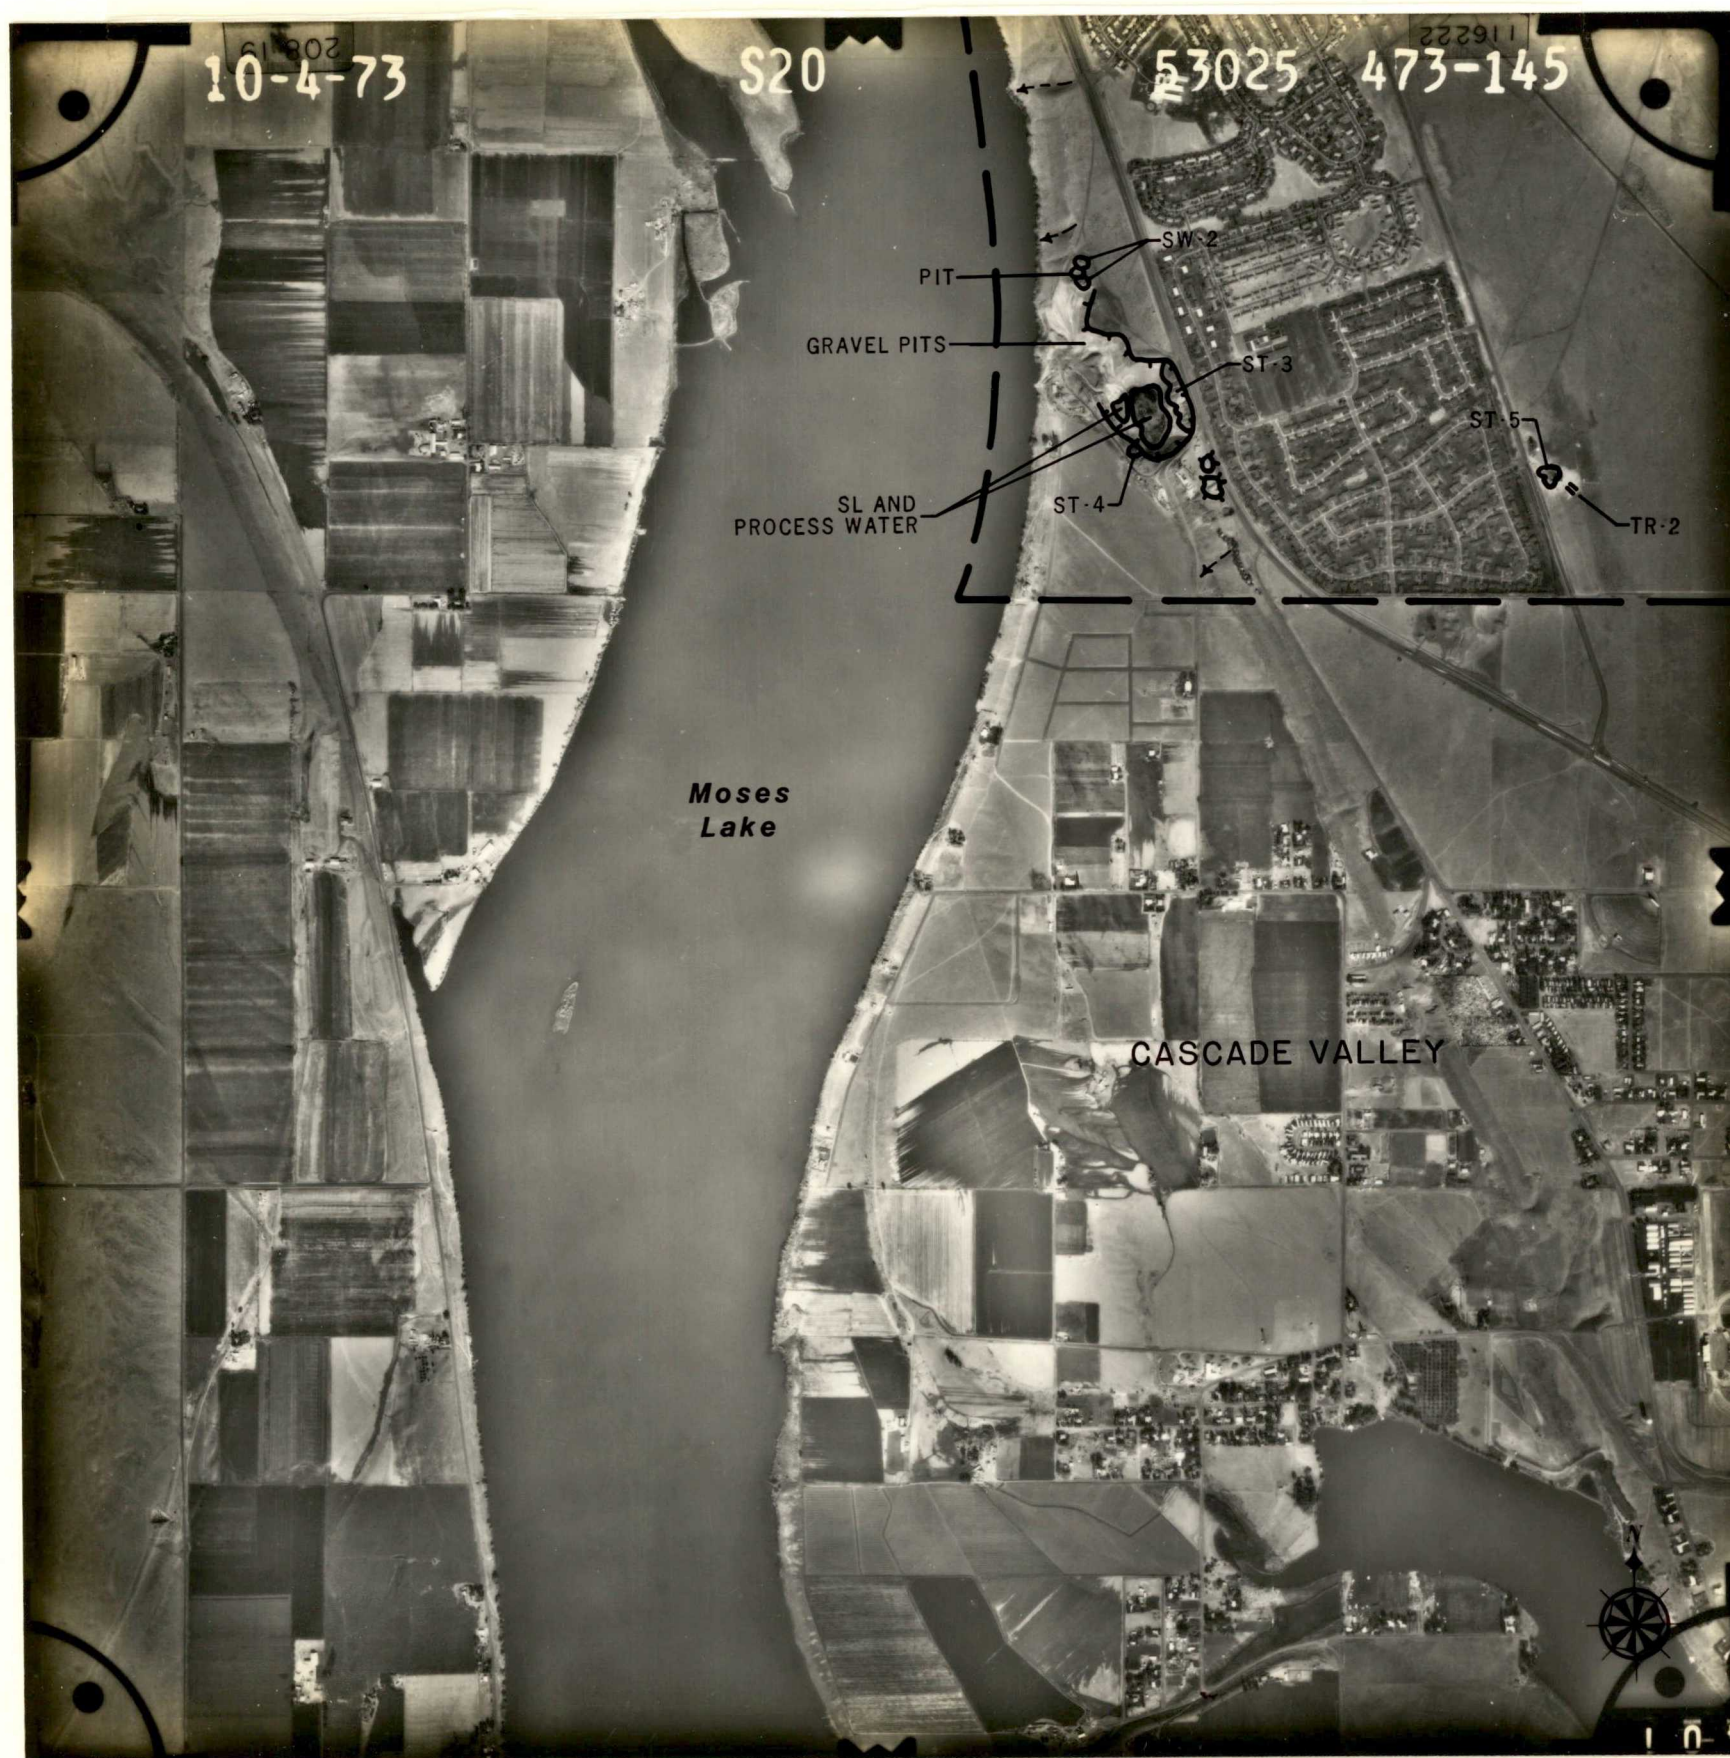
The photograph (Figure 6) provides coverage of a large gravel pit complex adjacent to the base residential area. The surrounding agricultural land of Cascade Valley is also visible. Potential environmental hazards are:

- SW-2: Two accumulations of solid waste located adjacent to a shallow pit.
- ST-3: Numerous light- and dark-toned streaks are visible on the slope of the gravel pit along Airway Road. These may be from disposal of solid or liquid material.
- ST-4: Heavy dark staining is noted at this point. The source is not evident.
- ST-5: The source of this dark stain near a small building is not evident.
- TR-2: Two small trenches are visible behind the same building as ST-5. They appear to be associated with construction activity.

In addition, large pools of standing water and process water from the gravel washing operations are located in the bottom of the gravel pits.

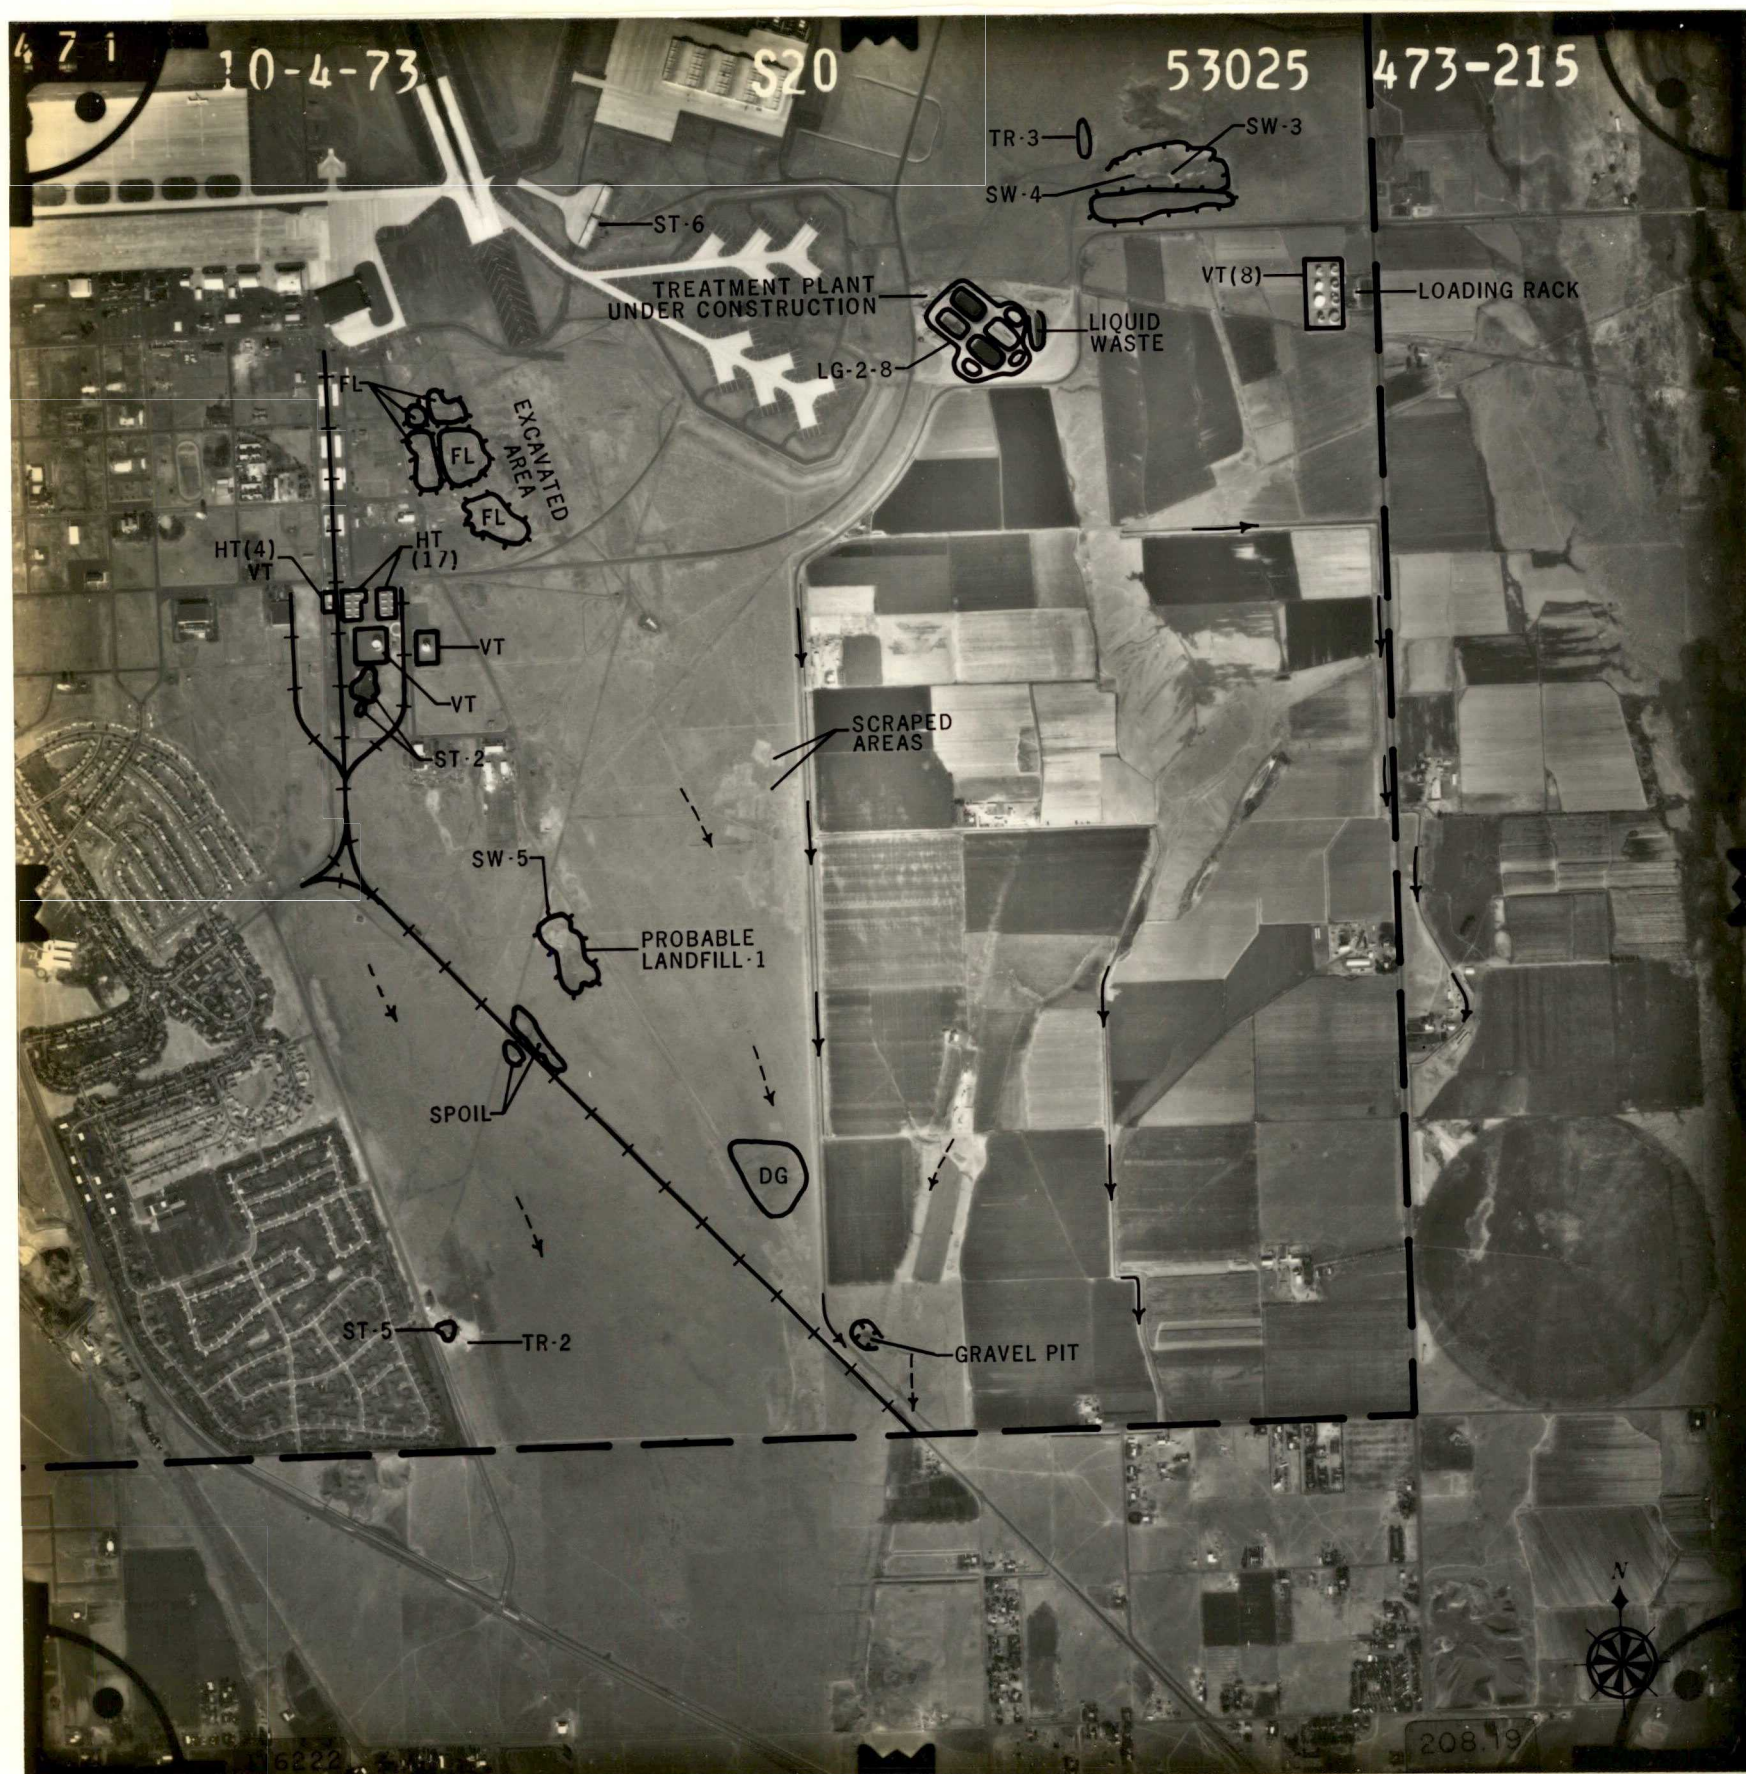
Figure 9. Larson AFB study area, October 4, 1973 (6 of 6). Approximate scale 1:20,000.

Figure 9 completes the 1973 coverage of the study area. An extensive agricultural area is present in the southeast corner of the area. These fields lie outside the military reservation boundary. Drainage throughout this area is to the south. Potential environmental hazardous are:

Probable Landfill-1: This mounded area shows signs of waste disposal. A significant accumulation of solid waste (SW-5) is noted on an outboard slope of the landfill's northern side.

In addition, an area of disturbed ground is located further south.

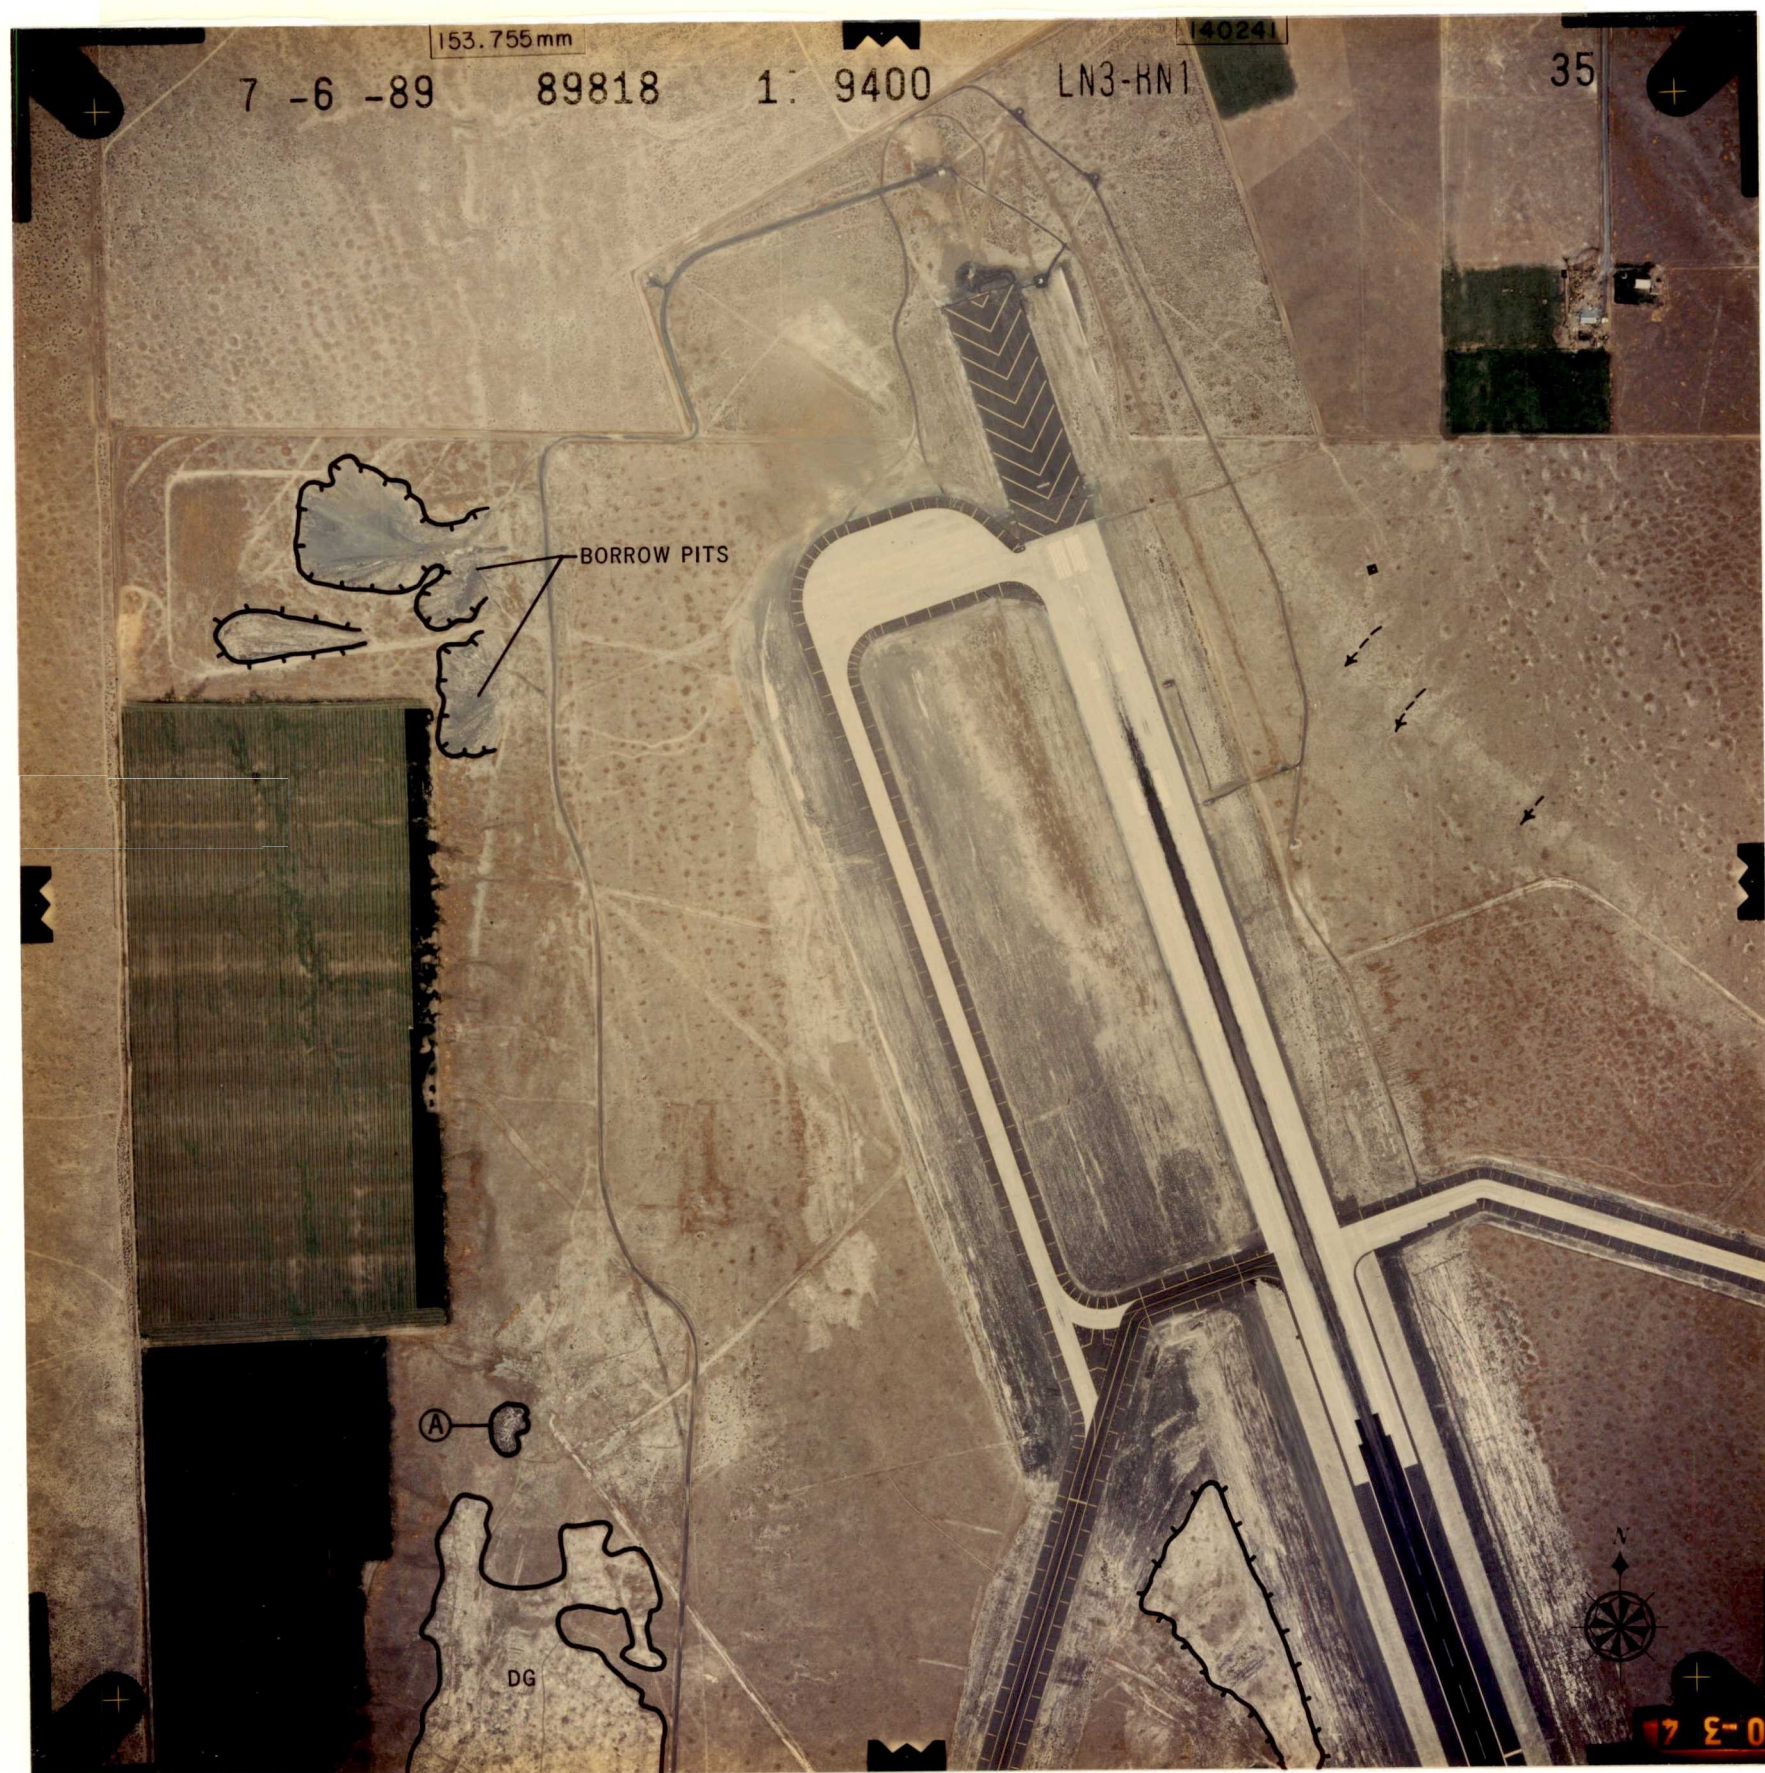
Figure 16 shows no new activity since 1973. The extent of the borrow pits and runways are the same as in that year. Potential environmental hazards are:

Annotation A: This dark solid material shows no change since 1973.

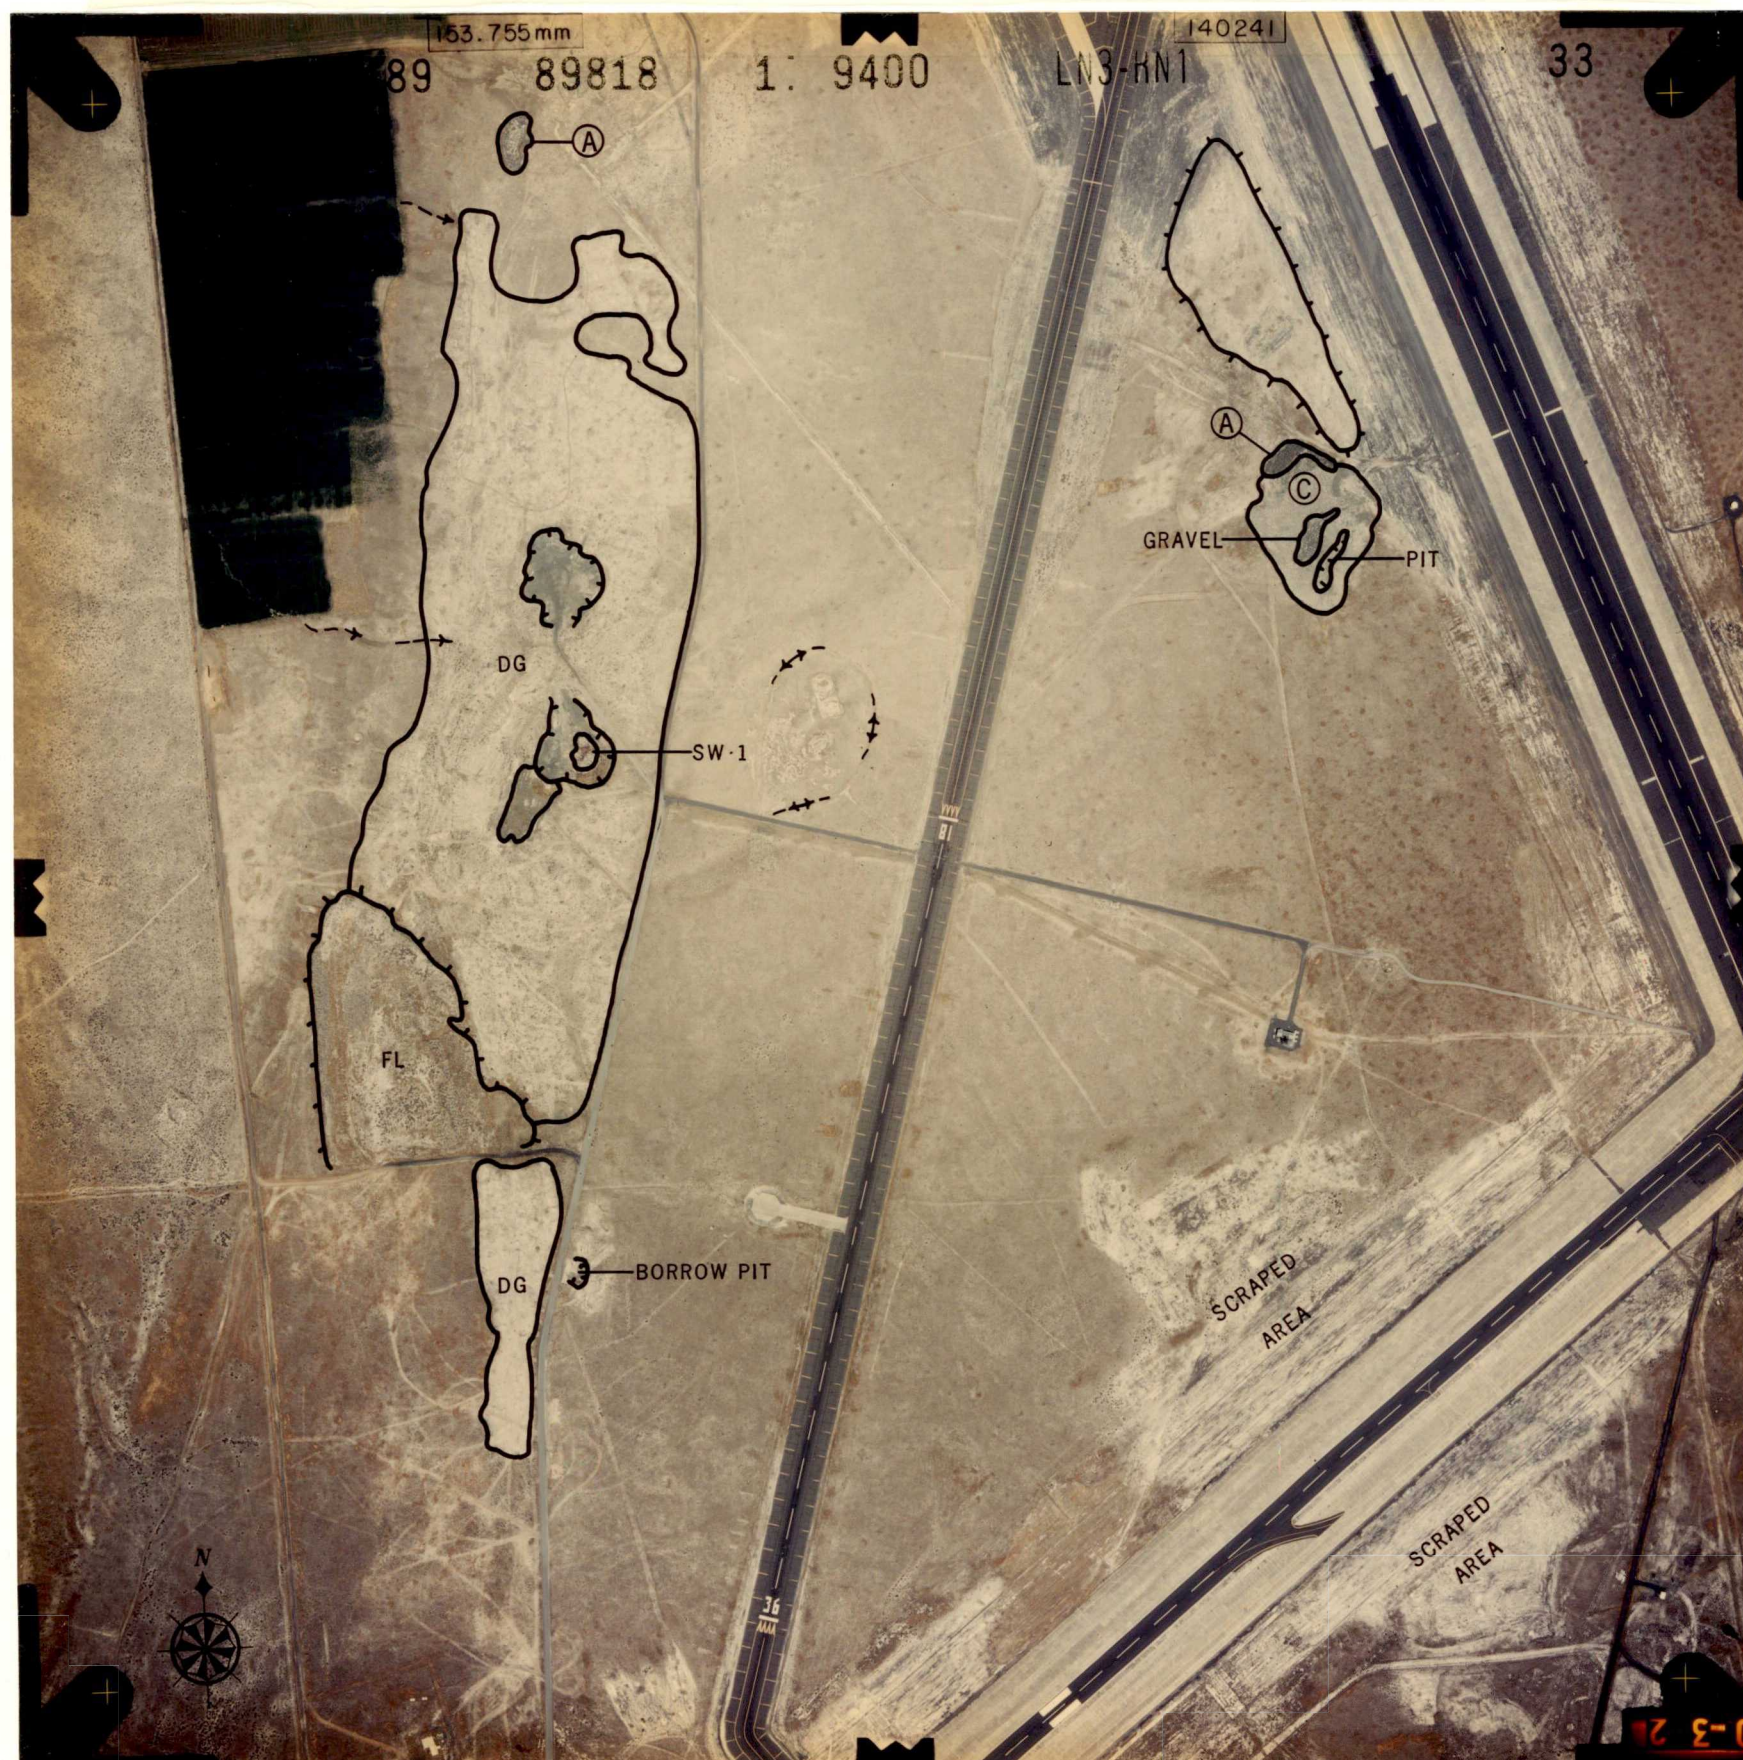
Figure 17 shows several features of interest. Potential environmental hazards are:

SW-1: The solid waste in this excavation consists of what appears to be construction rubble, crates, various rusting metal objects, and a grey-ash-like material. The extent of this solid waste seems to have increased since 1973.

Additionally, no change is noted at the disturbed ground areas or at the scraped areas on this frame. The previous burn areas now show a light soil tone.

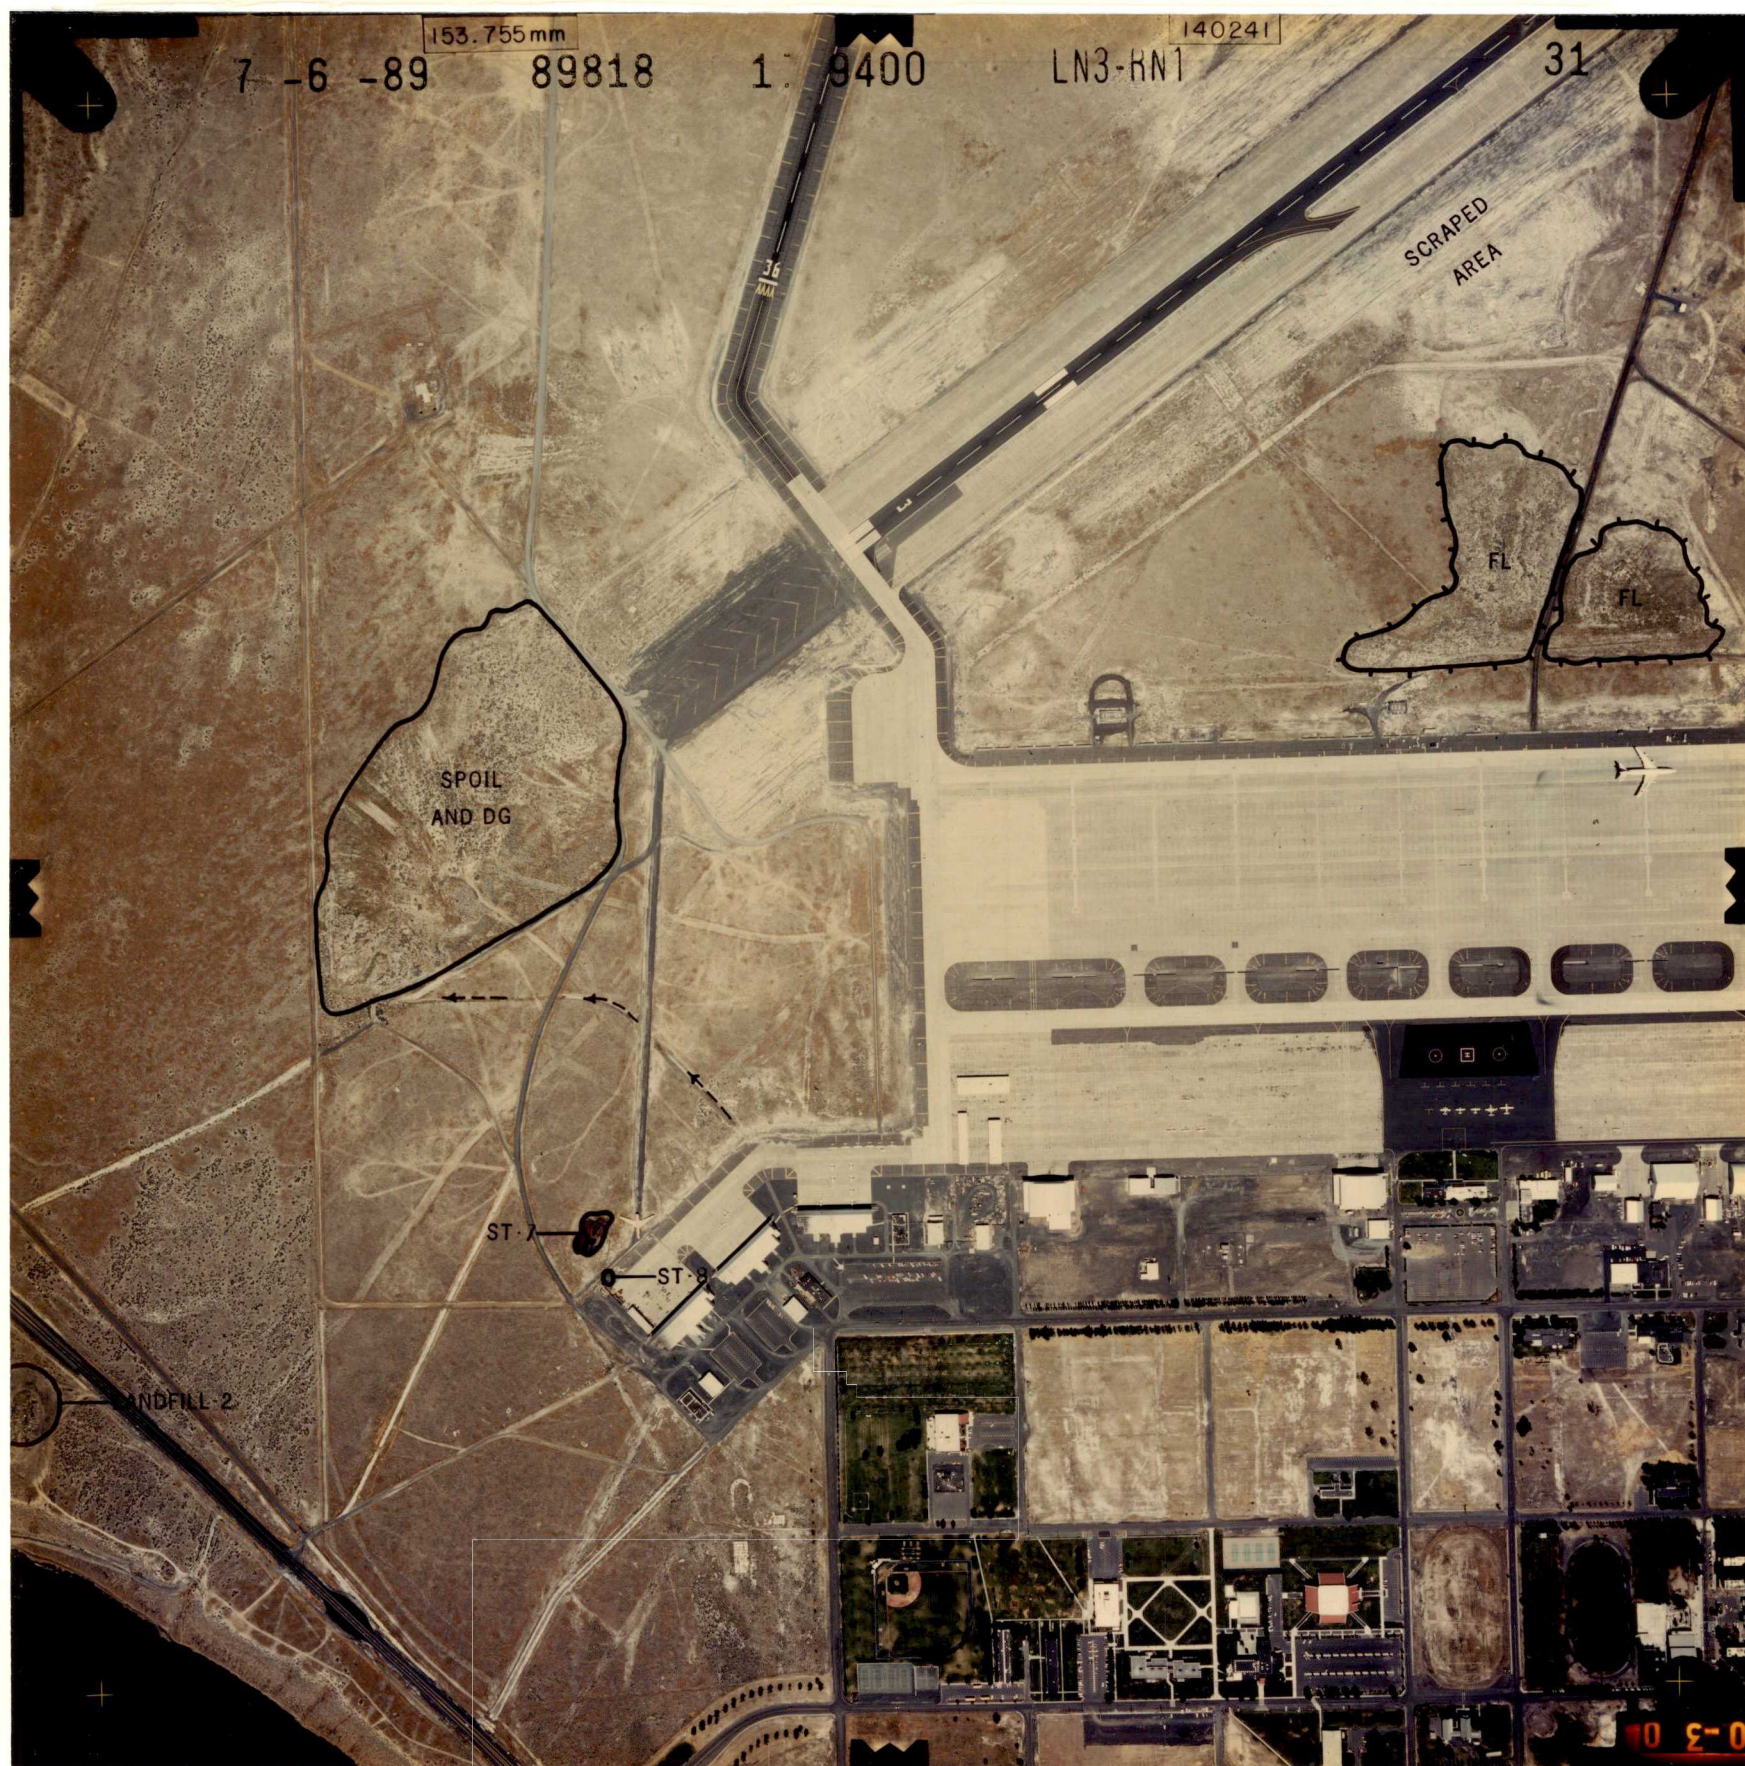
The photograph (Figure 18), shows two new features. Potential environmental hazards are:

ST-7: This is a fairly large dark oily liquid stain located on bare soil within a depression. The source is probably disposal of liquid from the maintenance buildings to the southeast.

ST-8: This is a small liquid release from the maintenance building nearby. It is located on pavement.

In addition, no change is noted at the extensive area of spill and disturbed ground. No waste disposal is evident at the fill area in the northeast part of the frame.
